1 Commission

Bekina Compounds NV commissioned the Braunschweig Civil Engineering Materials Testing Institute (MPA) to test penetration elements/tie points provided with BeSealed UFO sealing plug capable of swelling in water for water tightness, for use in structural elements made from concrete with a high water penetration resistance.

This document is the translated version of Assessment Report No. 5261/998/14b – Pan dated 31/10/2014. The legally binding text is the aforementioned German Assessment Report.

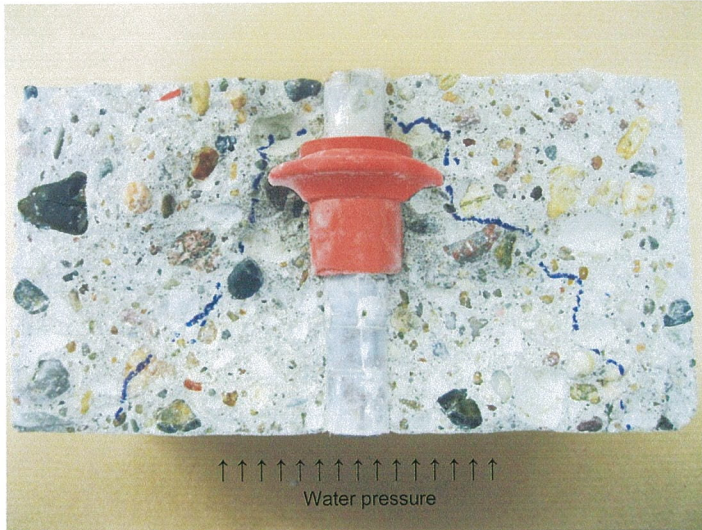
Fig. A2: Sample 1: anchor rod (ribbed steel $\text{\O} = 16 \text{ mm}$)

- Sample 1: anchor rod (ribbed steel, $\varnothing = 16$ mm) with "BeSealed Sealing Connector" sealing collar ($\varnothing_{\text{inside}} = 16$ mm, $\varnothing_{\text{outside}} = \text{approx. } 24$ mm, depth = 36 mm)

After the test for tightness, the samples were split in the middle, and the depth of water penetration was recorded (photos A2 to A5).

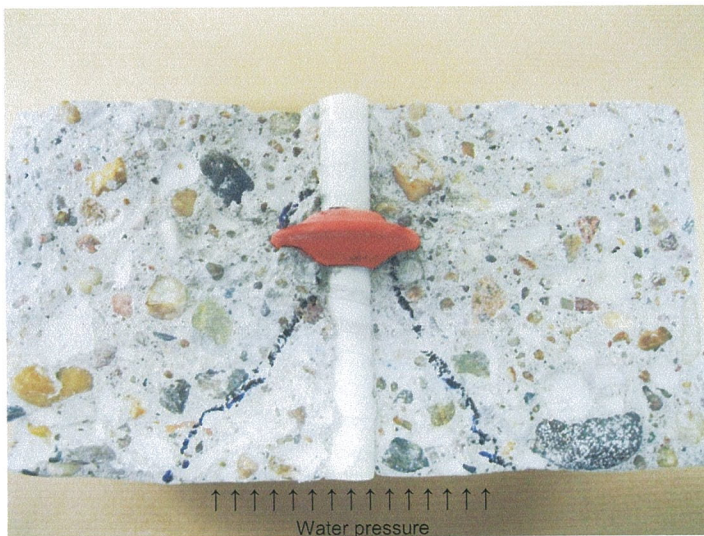
Fig. A3: Sample 2: glass-fibre rod (ribbed $\text{\O} = 14 \text{ mm}$)

- Sample 2: glass-fibre rod (ribbed; $\varnothing = 14$ mm) with "BeSealed Sealing UFO" sealing flange ($\varnothing_{\text{inside}} = 12$ mm, $\varnothing_{\text{outside}} = \text{approx. } 40$ mm, depth = 15 mm)

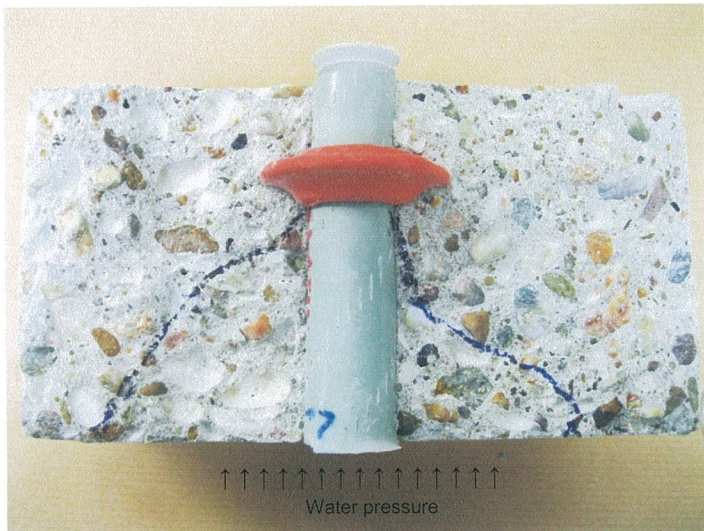
Fig. A5: Sample 4: plastic pipe ($\varnothing_{\text{inside}} = 22 \text{ mm}$, $\varnothing_{\text{outside}} = 26 \text{ mm}$); negative water pressure acting on the plug

- Sample 4: same as series 3; test with negative water pressure acting on the plug
